FINAL REPORT

FOR THE CONSTRUCTION OF NJIPTOH WATER PROJECT PHASE I EXTENSION

6.1.1. Construction of 50m³ Slow Sand Filter tank in stone masonry, reinforced concrete and disinfection of the whole water supply scheme involving the following activities:

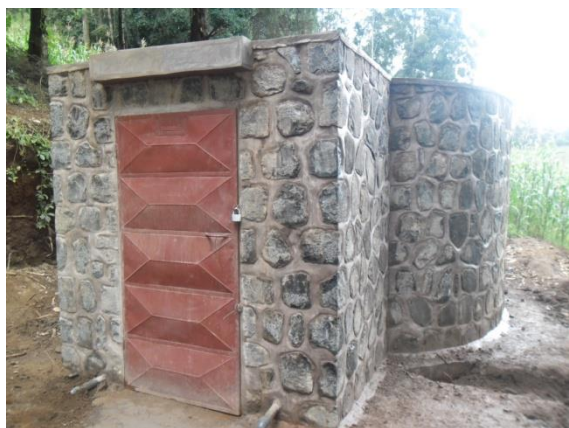
Front and right view of the SSF

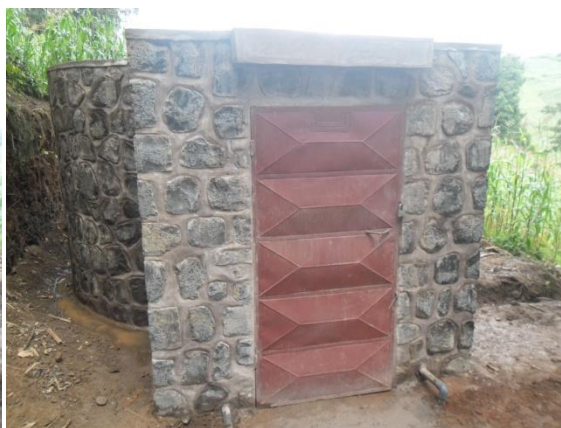
Front and left view of the SSF

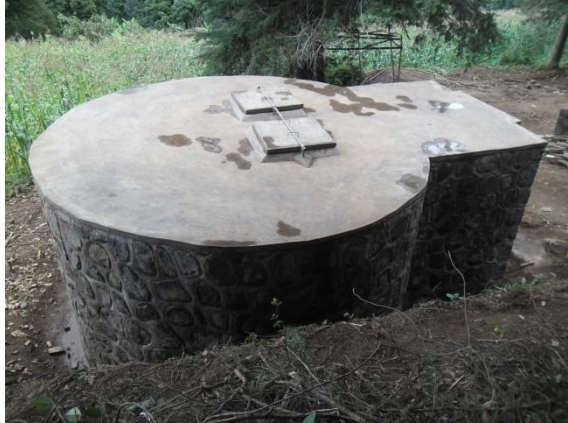
Top and left end view

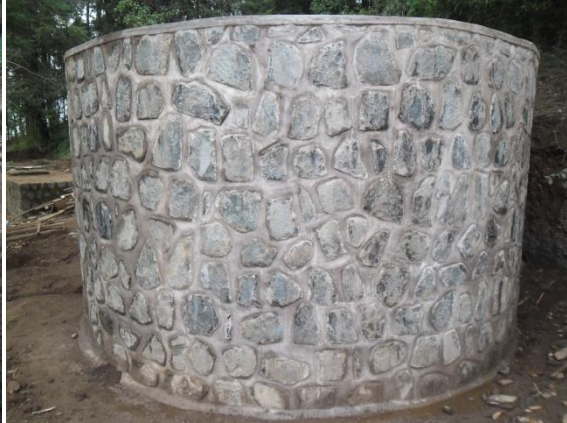
Rear View

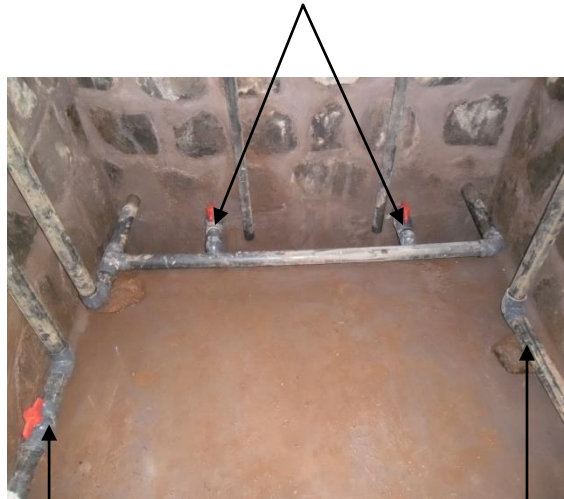
Outlet pipe

Inlet pipe

Interior of control chamber
